**Flood Control Project Maintenance  
Levee Inspections**

**Fall 2009 Levee Maintenance Deficiency Summary Report**

**Reclamation District No. 0307 Lisbon**

Waterway						Bank	Unit Miles	Inspection Start/End	Inspector
Unit No. 01 Sacramento River						Right	6.65	10/01/2009 10/01/2009	Herman Phillips

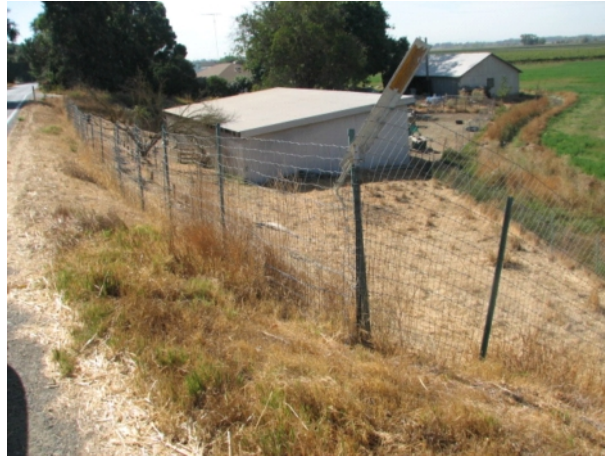
phillips\_20090924\_1.jpg

LMR No	Levee Mile		Category	Item	Location	Rating	Action/Comment	GPS Latitude/Longitude		Issue No. Photo
	Start	End						Start	End	
34	2.99	3.03	Earthen Levee	Encroachments	LS	PO	Fences Inspector Comments: Photo has been added to report to show the encroachment. The land owner has goats inside this fence area. There is no need for this fence to be on the levee section.	38.464055 ° -121.505350 °	38.463517 ° -121.505270 °	22 Y
35	3.00	3.03	Earthen Levee	Encroachments	LS	PO	Fences	38.464078 ° -121.505277 °	38.463537 ° -121.505208 °	973
36	3.00	3.04	Earthen Levee	Encroachments	LS	PO	Fences	38.464043 ° -121.505343 °	38.463505 ° -121.505290 °	961
37	3.05	3.13	Earthen Levee	Vegetation	WS	M	Remove the wild growth other than native grasses from the levee slopes.	38.463250 ° -121.505098 °	38.462127 ° -121.504943 °	90
38	3.17	3.28	Earthen Levee	Vegetation	WS	M	Remove the wild growth other than native grasses from the levee slopes.	38.461610 ° -121.504892 °	38.460097 ° -121.504552 °	89

Levee Mile Report Line	34
Start Levee Mile	2.99
End Levee Mile	3.03
Location	Land Side
Category	Earthen Levee
Item	Encroachments

unauthorized fence located landward in RD 307.

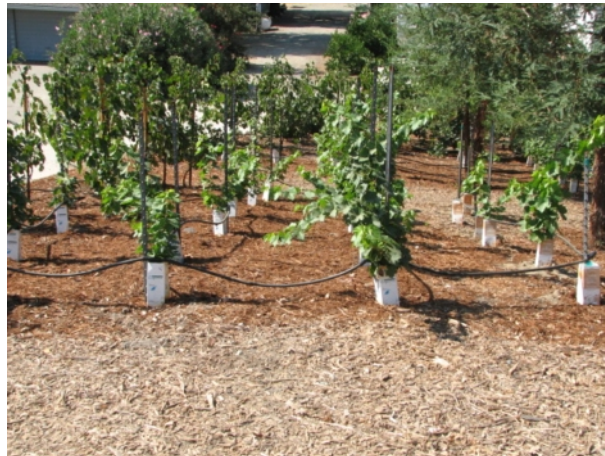
phillips\_20090924\_2.jpg

Levee Mile Report Line	53
Start Levee Mile	4.43
End Levee Mile	4.44
Location	Land Side
Category	Earthen Levee
Item	Encroachments

Unauthorized grape vines with driplines placed within levee shoulder and slope, levee miles 4.43 to 4.44 38.443798 121.50332 and 38.44365086 - 121.50322 land side. There is no Permit for this Encroachment.
